United States  
Department  
of Agriculture

Agricultural  
Research  
Service

Conservation  
Research  
Report Number 43

# **Use of Vegetation To Stabilize Eroding Streambanks**

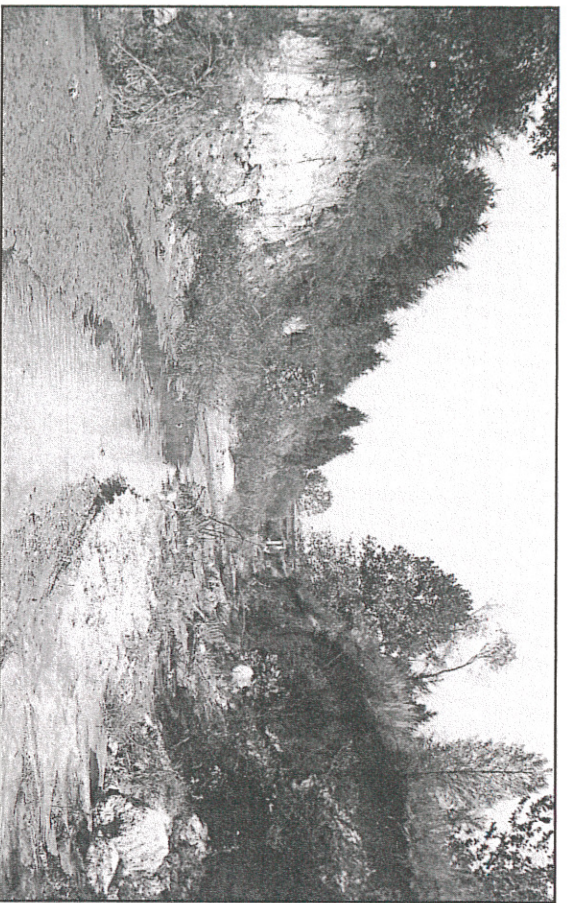
Figure 2. Typical channel cross section of Johnson Creek

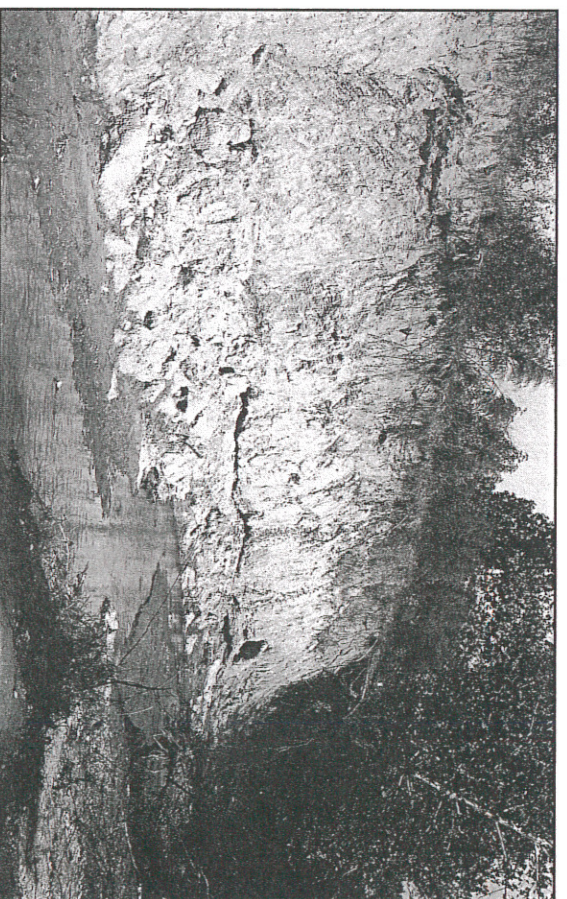
Two channels, Johnson Creek and Goodwin Creek, in Panola County near Batesville, Mississippi, were selected for study (fig. 1). Generally those channel banks are composed of alluvial soils; that is, they contain clay, silt, sand, gravel, or similar material deposited by flowing water. In most reaches (the length of a stream referenced to definable objects or fixed points), the channel bottom or bed is a mixture of sand and gravel (Grissinger and Bowie 1984). Along the reaches where the bed instability is most pronounced, the channel banks are vertical and quite deep (fig. 2). Bank instability is due primarily to a high bank, erosion of the bank toe, and internal bank pressure created by the lateral movement of groundwater. Figure 3 illustrates the channel bank failure that is prevalent throughout the study area.

Figure 3. Johnson Creek bank failure due to undermining

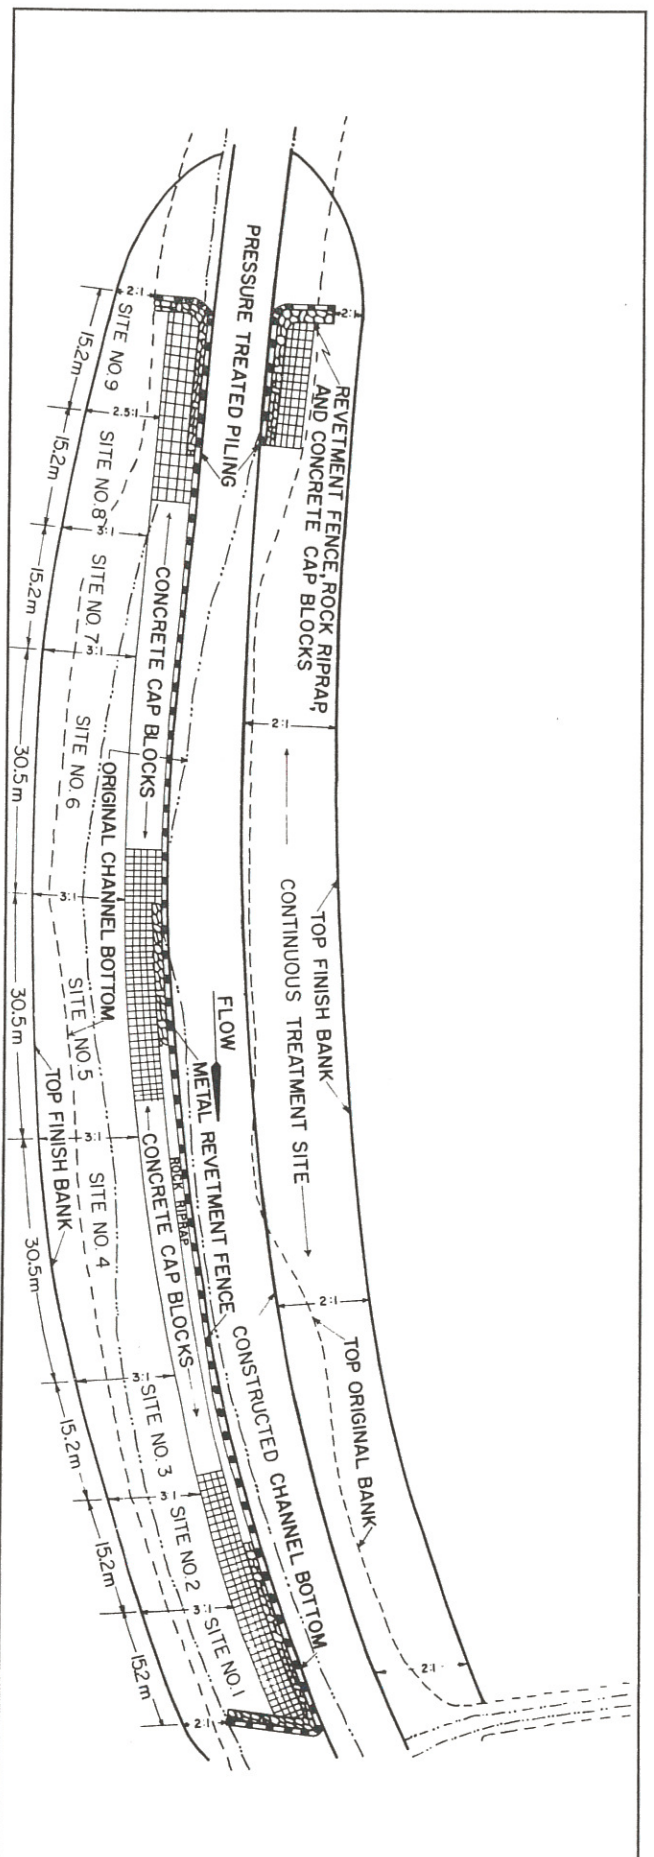
Figure 4. Site plan of Johnson Creek study reach no. 1

A site plan of the Johnson Creek study reach no. 1 is shown in figure 4. Nine treatment sites, 15.2–30.5 m (50–100 ft) long, were established on the shaped concave bank of the bend. In addition, the entire length of the convex bank was considered one treatment site. The materials used for treatment are listed in table 1. The finished concave bank consisted of fill material excavated from the opposite (convex) bank. The convex bank was shaped to a 2:1 slope without structural materials, except for a hard point constructed at the upstream end (fig. 4). The concave bank was shaped to 2:1, 2.5:1, and 3:1 slopes, and structural materials were used as shown in figure 4. Sloping the banks in this study reach increased the channel cross-section area by about 45 percent. This increased area more than offset the retarding effect of vegetative and structural materials on the capacity of the channel to transport flood flows. The streambed was relocated toward the convex bank in order to decrease and smooth the curvature of the bend, to flatten the bank slope for the concave bank without infringing on adjacent farmland, to establish a more uniform bottom width, and to provide the needed fill material.

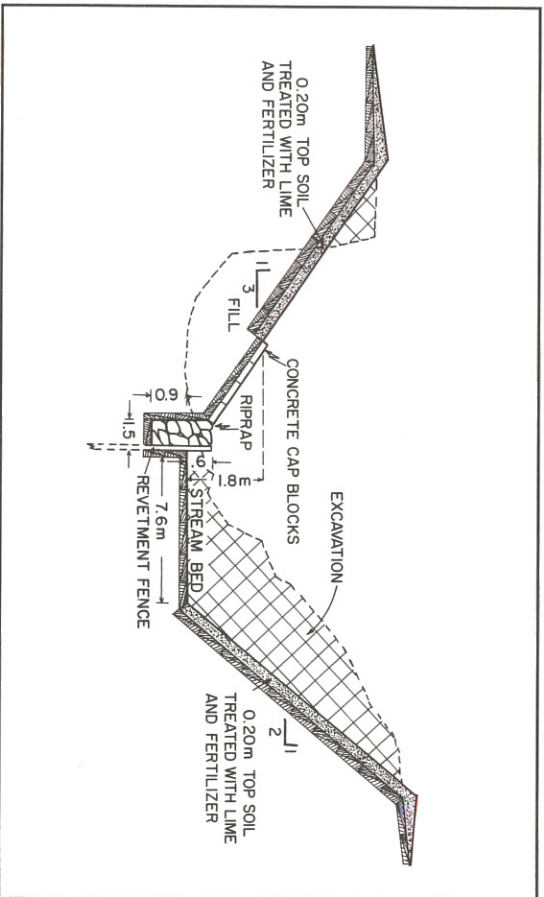
Figure 5. Cross section of typical treatment of Johnson Creek study reach no. 1

For Johnson Creek study reach no. 1, a trench 1.5 m (5 ft) wide by 0.9 m (3 ft) deep was excavated at the toe line of the finished bank along the concave bank. Creosote-pressure-treated pilings with a minimum tip diameter of 0.2 m (8 inches) and 4.9 m (16 ft) were driven on 2.4-m (8-ft) centers in the excavated toe trench and adjacent to the channel bottom. Each piling was driven to a depth of 4.3 m (14 ft), and 0.6 m (2 ft) remained above the finished grade of the streambed. A chain link fence of 9-gauge galvanized steel fabric, 1.5 m (5 ft) high, was attached to the bank side of the pilings and even with the top of the pilings. The toe trench was back-filled with stone riprap to the top of the fence (fig. 5). The gradation or rock size for the riprap was determined from the USDA Soil Conservation Service design criteria, which required 50–75 percent of the stones to weigh more than 34 kg

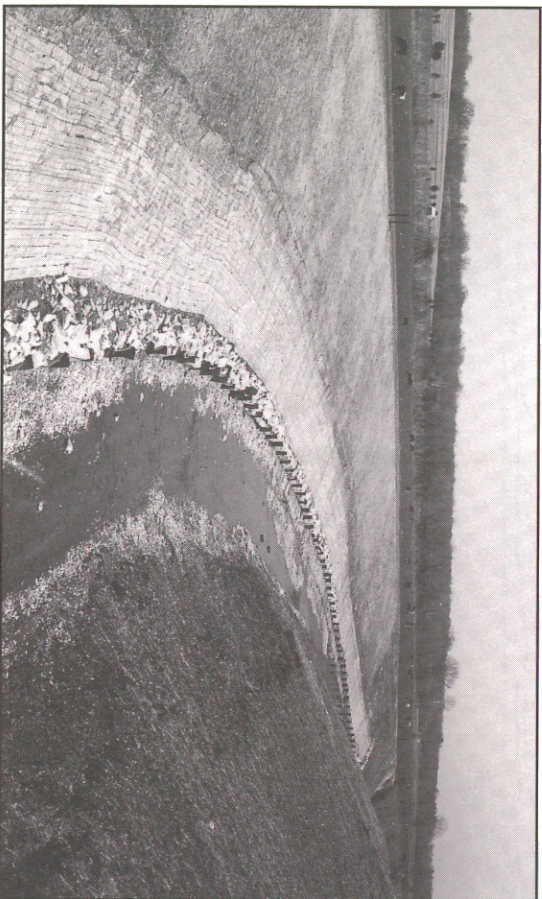
Figure 7. Upstream view of Johnson Creek study reach no. 1 after construction

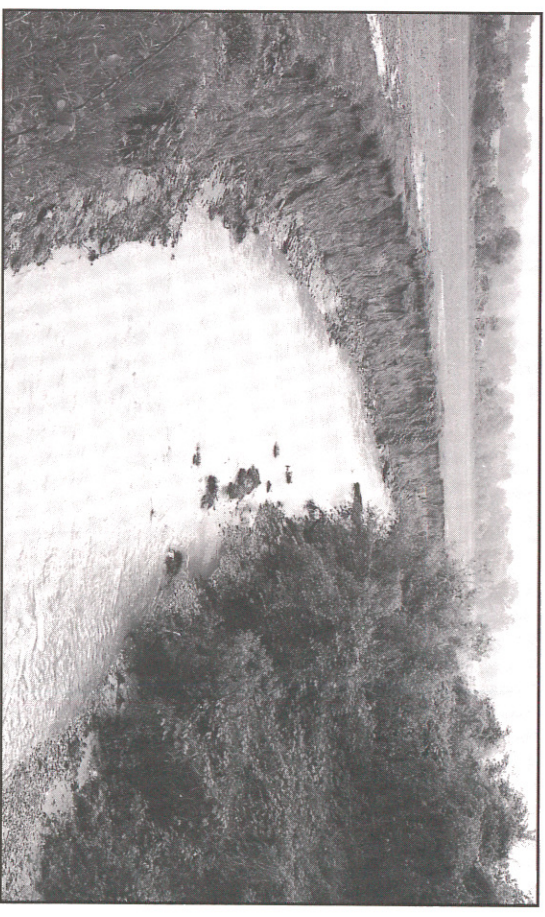
Figure 6. Upstream view of Johnson Creek study reach no. 1 before construction

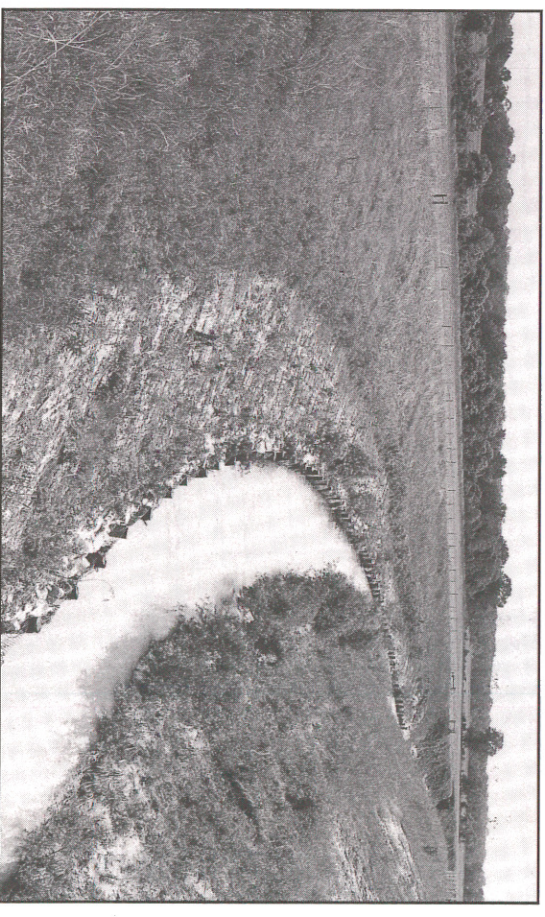
Figure 8. Upstream view of Johnson Creek study reach no. 1 after six growing seasons

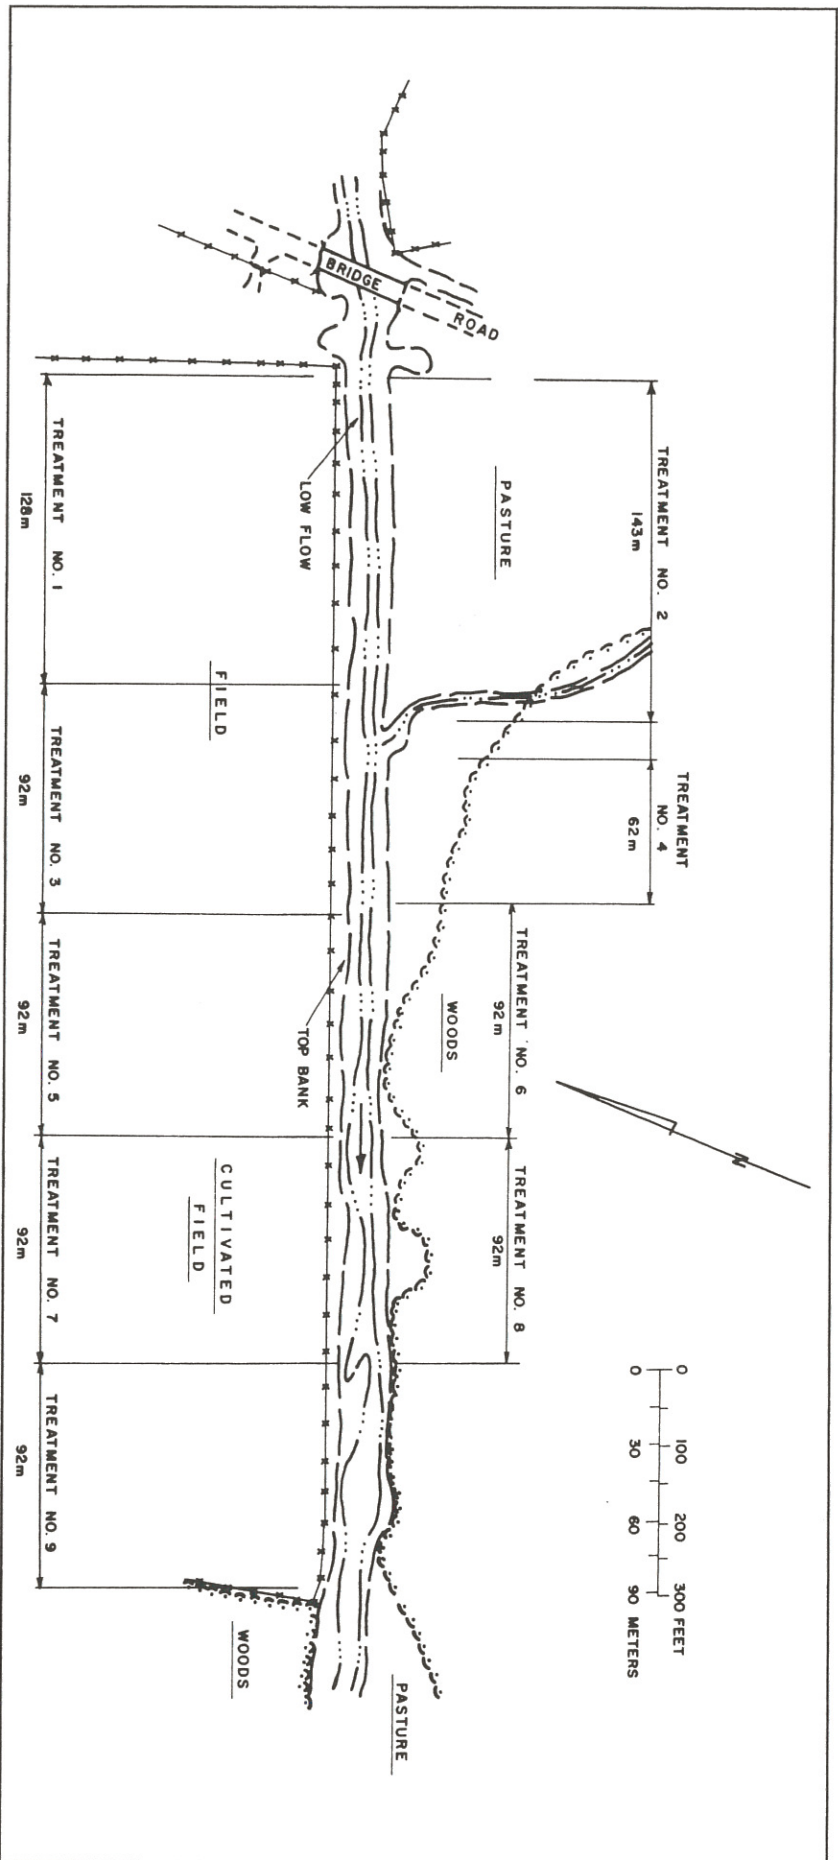
Figure 9. Site plan of Johnson Creek study reach no. 2

A site plan for Johnson Creek study reach no. 2 is shown in figure 9. Nine treatment sites 62–143 m (200–470 ft) long were included in the study. The materials used for treatment are listed in table 1. The top 0.6 m (2 ft) of soil along both sides of the channel was stockpiled during bank shaping and later used on the prepared seedbeds.

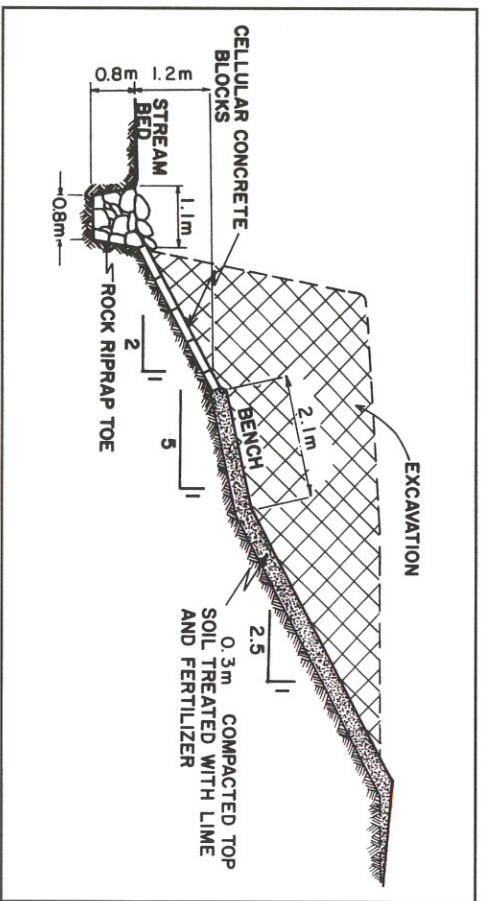
Figure 10. Johnson Creek study reach no. 2: Cross section of excavated bench, with lower bank and entrenched toe protected with structural materials

In Johnson Creek study reach no. 2, the lower bank was protected with riprap, or cellular concrete blocks, or concrete cap blocks. Plastic filter cloth of woven polypropylene fabric was installed between the revetment and the subgrade. The design height of 1.2 m (4 ft) of structural revetment on the lower bank was equal to the maximum depth of flow expected for 90–95 percent of annual storm events. The lower bank was constructed to a 2:1 slope, the bench (2.1 m or 7.0 ft wide) to a 5:1 slope, and the upper bank to a 2.5:1 slope. The bench was planted with woody

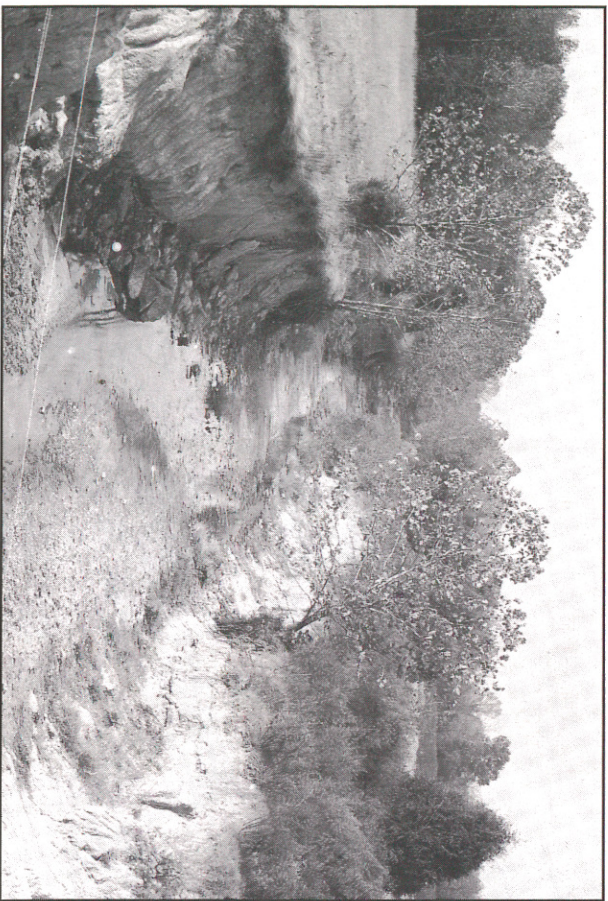
Figure 12. Downstream view of Johnson Creek study reach no. 2 before construction

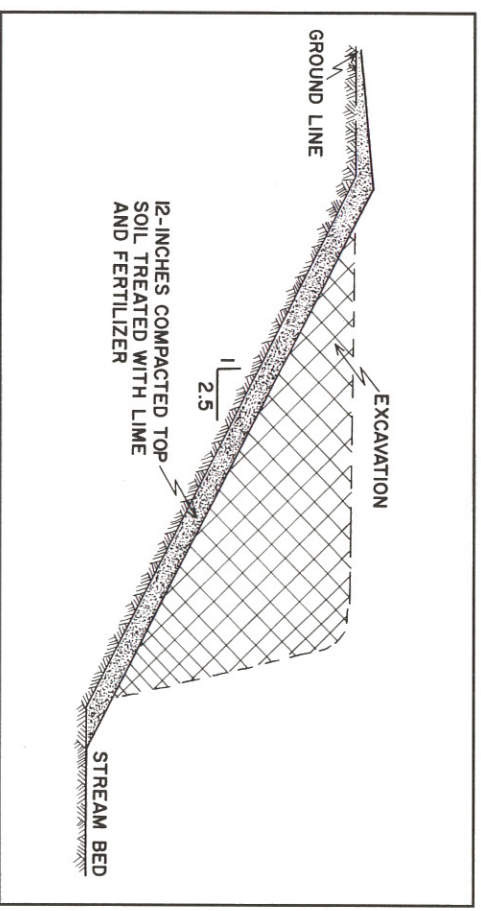
Figure 11. Johnson Creek study reach no. 2: Cross section of typical sloped bank without structural materials

species and the upper bank with herbaceous species. Four sites were constructed to a continuous 2.5:1 slope without structural materials (fig. 11). After treatment with fertilizer and lime, the entire bank was planted with various species of herbaceous vegetation. Figure 12 is a downstream view of the study reach before construction. The same location after completion of construction is shown in figure 13 and after nine growing seasons in figure 14. Sloping the banks in this study reach increased the channel cross-section area by about 35 percent.

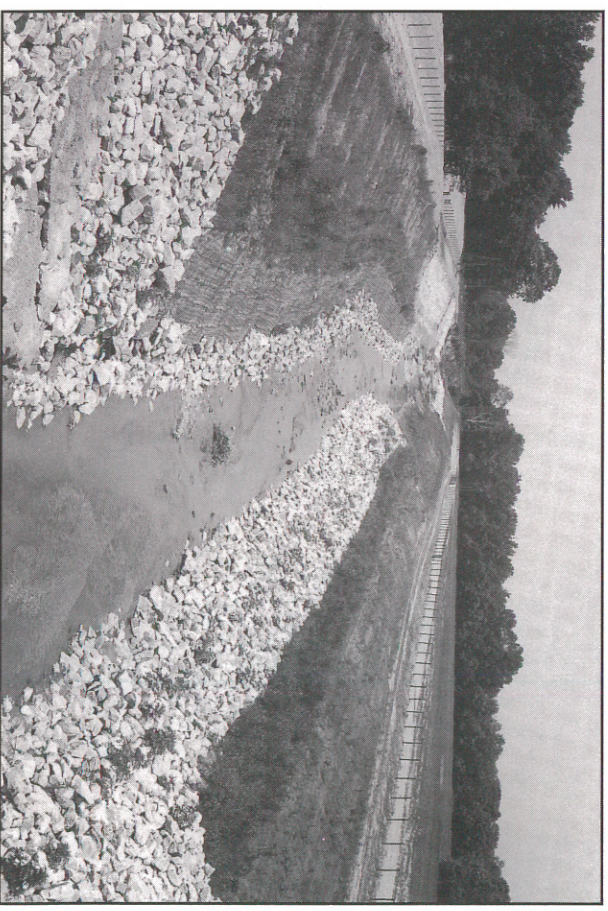
Figure 13. Downstream view of Johnson Creek study reach no. 2 after construction

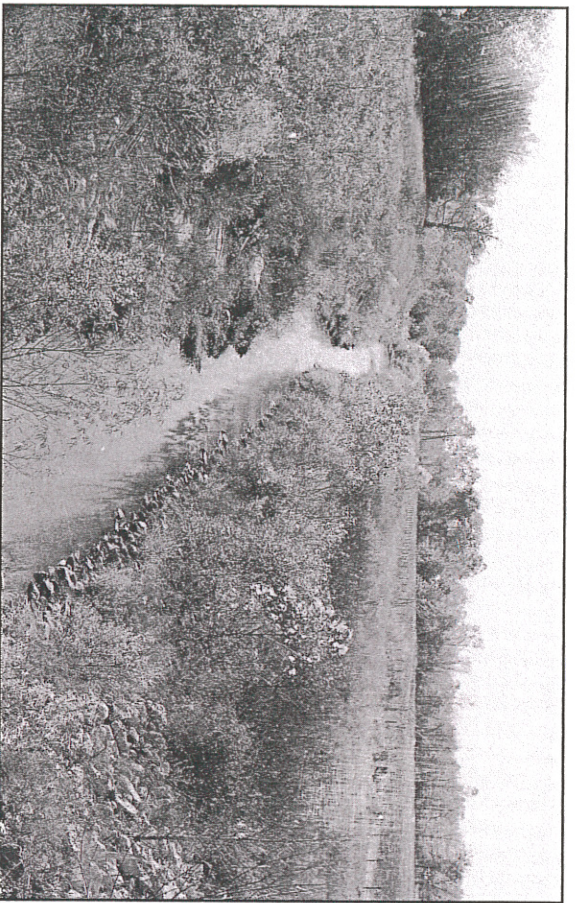
Figure 14. Downstream view of Johnson Creek study reach no. 2 after nine growing seasons

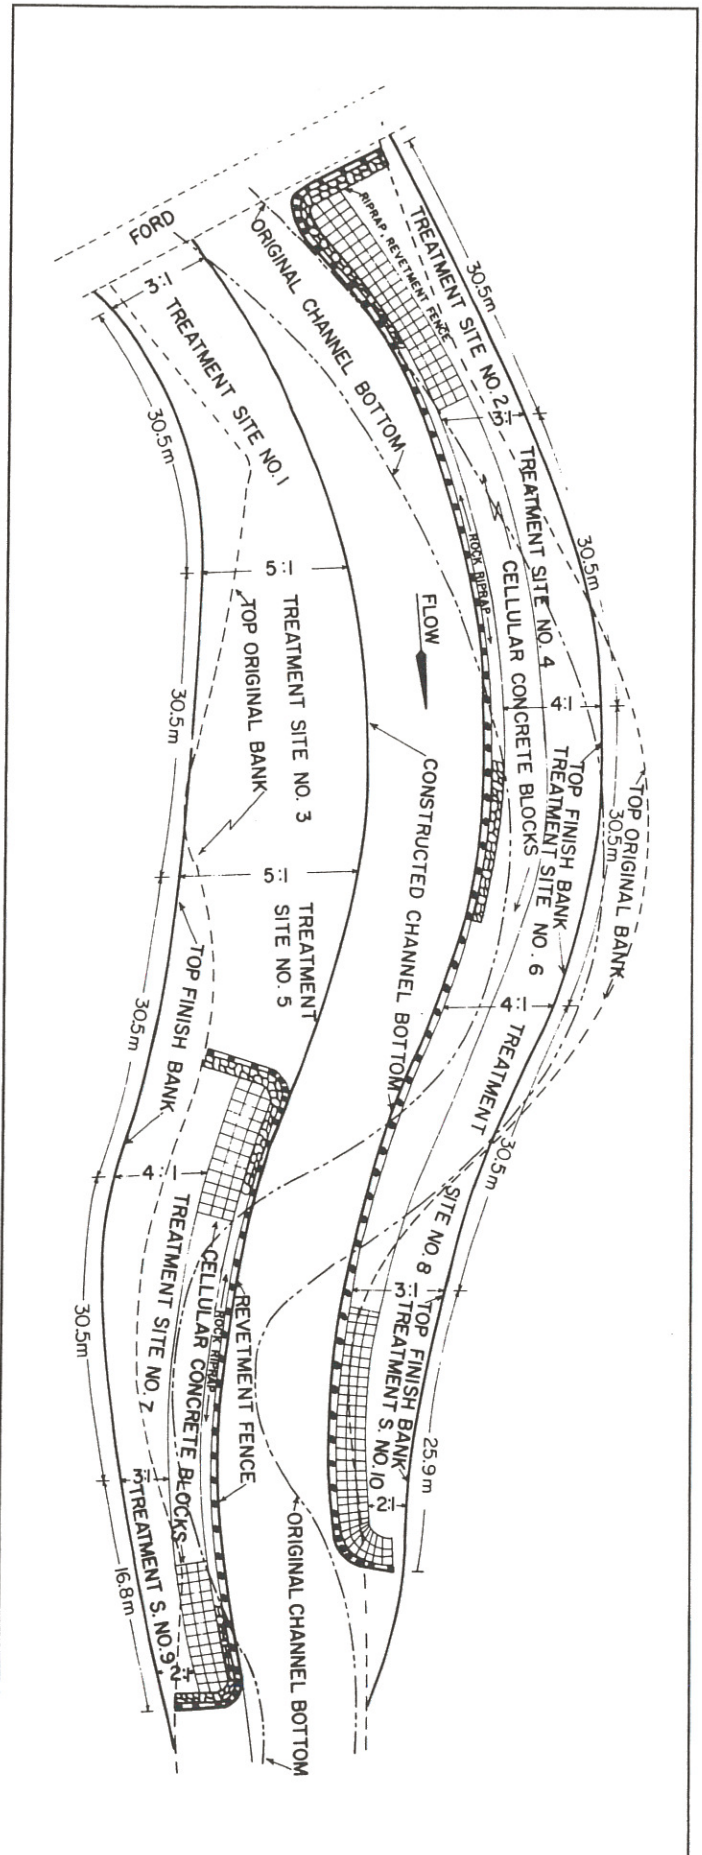
Figure 15. Site plan of Goodwin Creek study reach

A site plan for the Goodwin Creek study reach is shown in figure 15. Ten treatment sites 16.8–30.5 m (55–100 ft) long were included in the study. Seven of those sites, 16.8–30.5 m (55–100 ft) long, were on the concave banks. Three sites, each 30.5 m (100 ft) long, were on the convex bank. The materials used for treatment are listed in table 1. Soil excavated from the convex bank was used for fill material along most of the concave bank. The concave bank was shaped to 2.5:1, 3:1, and 4:1 slopes, and structural materials were used as shown in figure 15. The convex bank was shaped to 3:1, 4:1, and 5:1 slopes without structural materials. Sloping the banks in this study reach increased the channel cross-section area by about 25 percent. The streambed was relocated toward the convex bank for the same purpose stated for Johnson Creek study reach 1. Also, the same specifications and method of construction for the concave bends were used (fig. 16), except as follows: The lower bank was protected with cellular concrete blocks 0.11 X 0.41 X 0.61 m (4.5 X 16 X 24 inches) weighing 41 kg (90 lbs) each. The design height of 1.5 m (5 ft) of structural revetment on the lower bank was equal to the maximum depth of flow expected for 90–95 percent of annual storm events and the additional erosive force expected on the concave bends. The upper banks were planted with herbaceous and woody vegetation.
